Manhole Inspection Summary

Manhole # S25QQ1004MH

Insp Date: **3/28/07 9:46 AM**

Location Address: **8 CLUB RD**

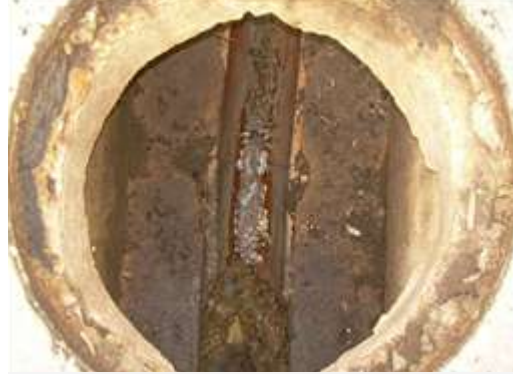
Top View

Channel and Bench debris.

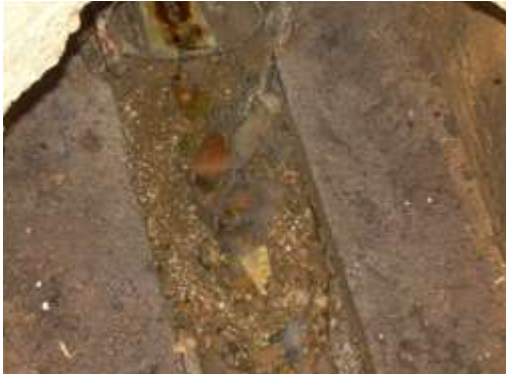
Defect

Condition: ☐ Sound ☒ **Cracked** ☐ Root Intrusion ☒ **Deteriorated** ☐ Leaks ☒ **Debris**

Broken Channel and debris.

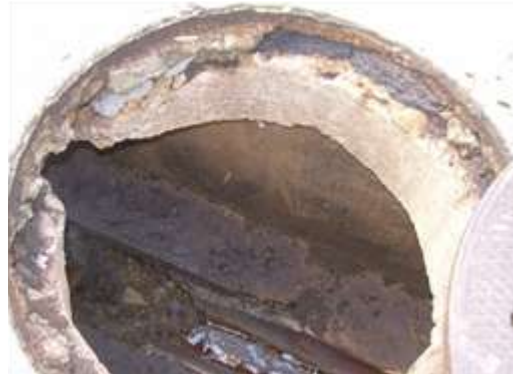
Defect

Condition: ☐ Sound ☐ Cracked ☐ Root Intrusion ☐ Loose Brick ☒ **Deteriorated**

Infiltration: ☐ None ☒ **Joint** ☐ Cracks ☐ Mortar ☐ Roots ☒ **Wall**

Adjustment infiltration and deteriorated

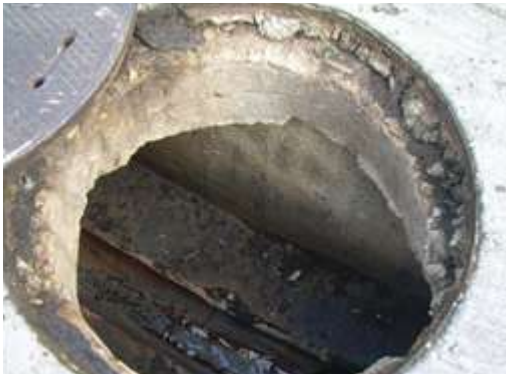
Defect

Frame offset. Adjustment deterioration and infiltration.

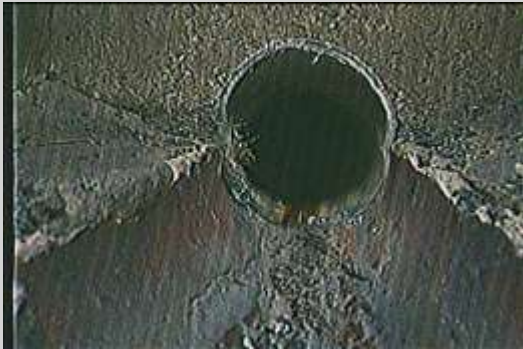
6 in. Circular Gravity Sewer Pipe Out @ 12 O'Clock

Channel deterioration and infiltration.

Infiltration: **Evidence** Pipe Seal Cond: **Roots**
